Beal Early Childhood Center

Existing Conditions Report

DECEMBER 18, 2017

3.1.4 EVALUATION OF EXISTING CONDITIONS

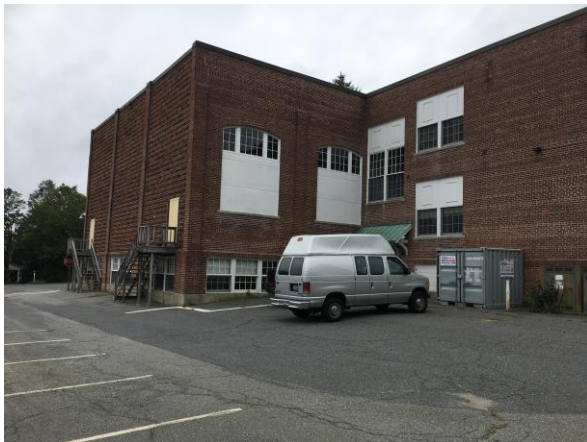
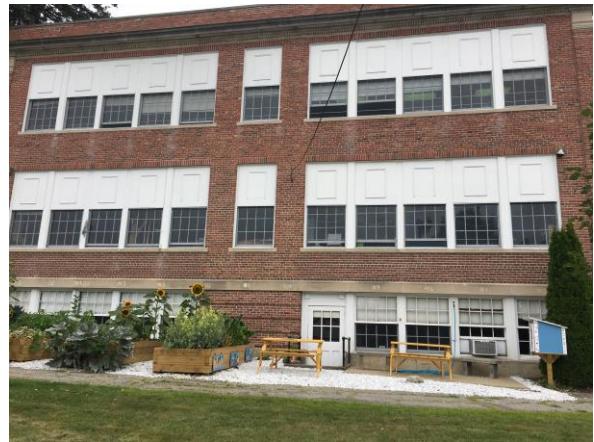
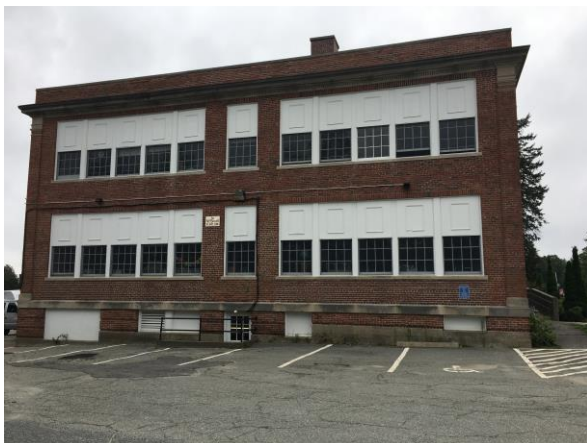
Masonry walls: generally in good condition with selective repointing, concrete foundation repair recommended. From visual inspection only, most of the stone banding and detailing including the main entry column portico and school name entablature appear to be in good condition raking and caulking of joints recommended. Uninsulated exterior masonry walls are deficient by contemporary standards for energy efficiency.

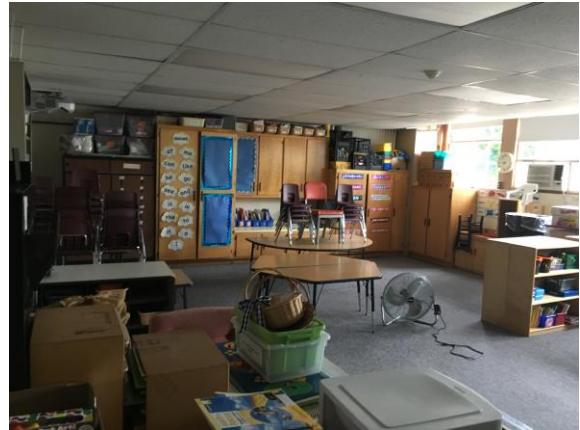
Flooring: It is assumed that original wood finish flooring has been covered (except in the gymnasium) by a variety of finishes including: asbestos composition tile, vinyl composition tile, and carpet over the years. Refer to the hazardous material report for estimated quantities of asbestos tile. All flooring is in poor to fair condition and full replacement would be recommended. The condition/existence of the original wood flooring is unknown with the exception of the gym floor.

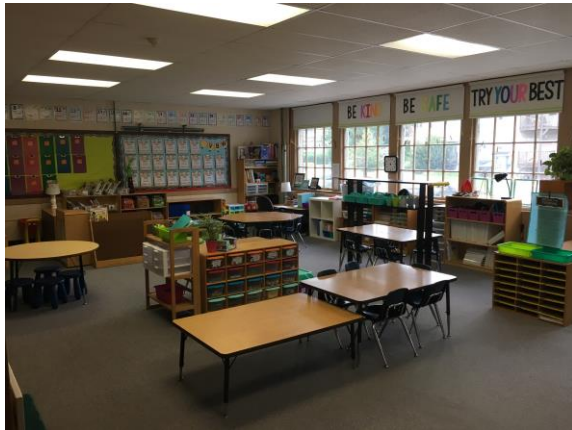
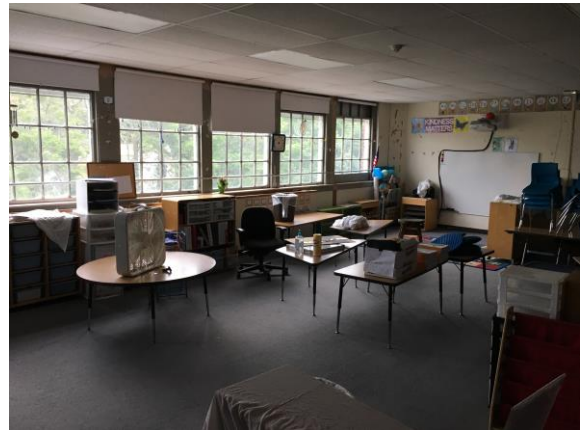
Windows: Original wood sash, single paned with drafty conditions and full replacement is recommended (see notes on exterior materials) including sills. New window shades have been installed and are in fair condition.

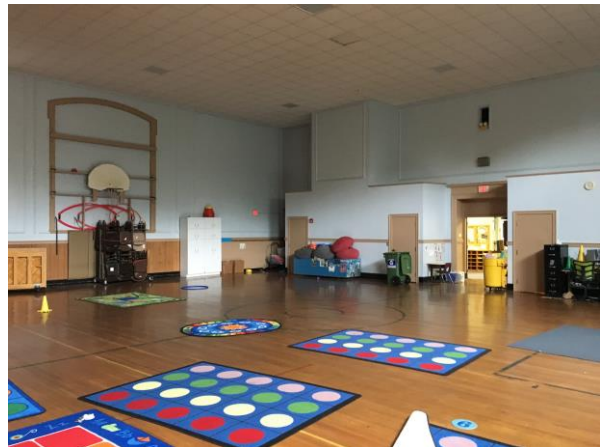
Gymnasium: features a hardwood athletic floor of undetermined age with sanding and refinishing recommended if it is to be maintained. Thickness testing is recommended to determine if it is sufficient for additional refinishing. Suspended acoustical ceiling of fair condition probably covers an original plaster ceiling. Walls are plaster with some infill and panelized painted trim that may be original. Various additions have been made to accommodate storage needs and the elevator installation. Egress from this space is facilitated by exterior uncovered stairs that would not meet current code for an educational use.

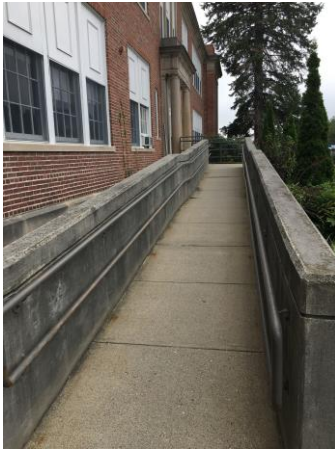
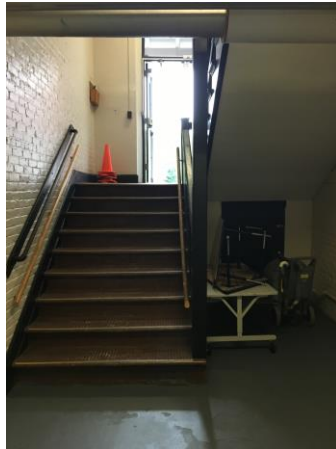
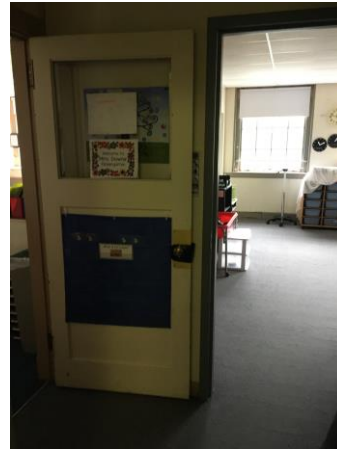
Accessibility: Since the building was constructed in 1922, accessibility requirements have changed significantly. Many renovations to the building have been made to upgrade to accessible standards including: exterior and interior ramps, toilet room renovations including accessible stalls, installation of lever door hardware. Accessibility deficiencies noted include:

- Exterior ramp does not include handrail extension at the end as required by current code
- Stairs do not have tapered nosings or handrail extensions
- Some doors do not have lever hardware
- Door clearances at corridor do not meet requirements in many cases (see Interior Materials – Doors narrative above). Depending on the building use for a major renovation, this might be a reasonable condition to petition for variance approval through the Architectural Access Board (AAB).

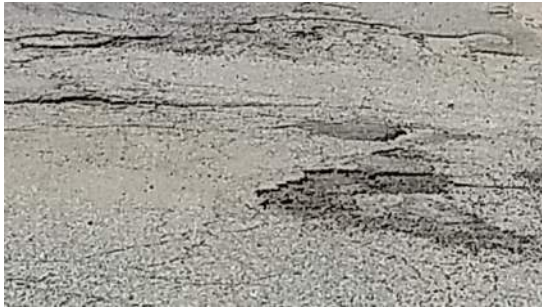
Picture 1: Pavement Deterioration

Nearly all of the bituminous pavement on the Site is in a poor/failing condition. Under any redevelopment scenario, all paved areas and curbs affected by the project are likely to require replacement.

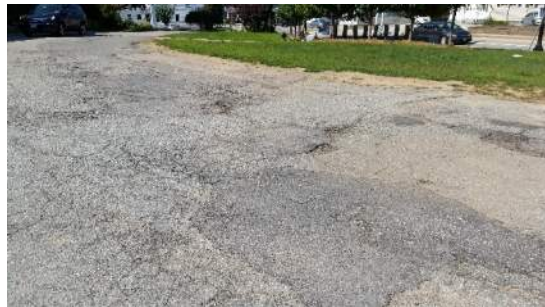
Picture 2: Pavement Deterioration

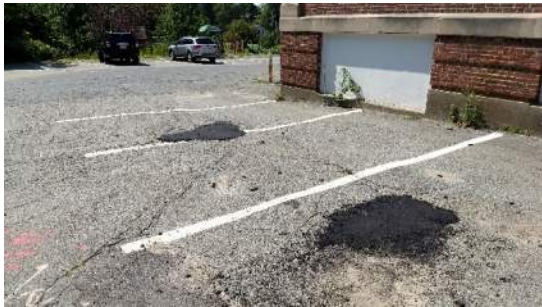
Picture 3: Pavement Deterioration

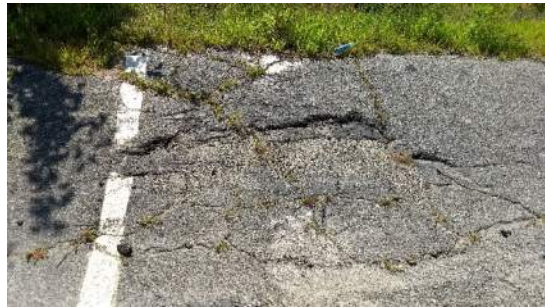
Picture 4: Pavement Deterioration

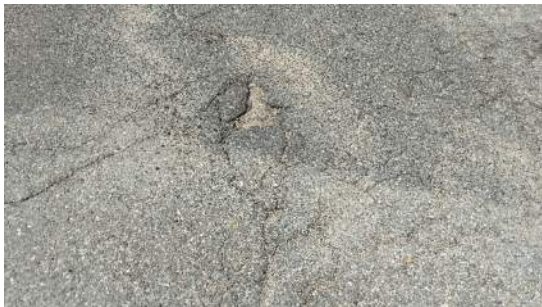
Picture 5: Pavement Deterioration

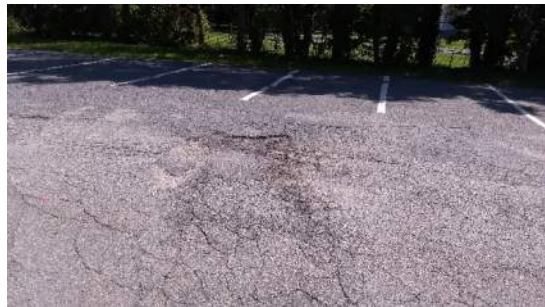
Picture 6: Pavement Deterioration

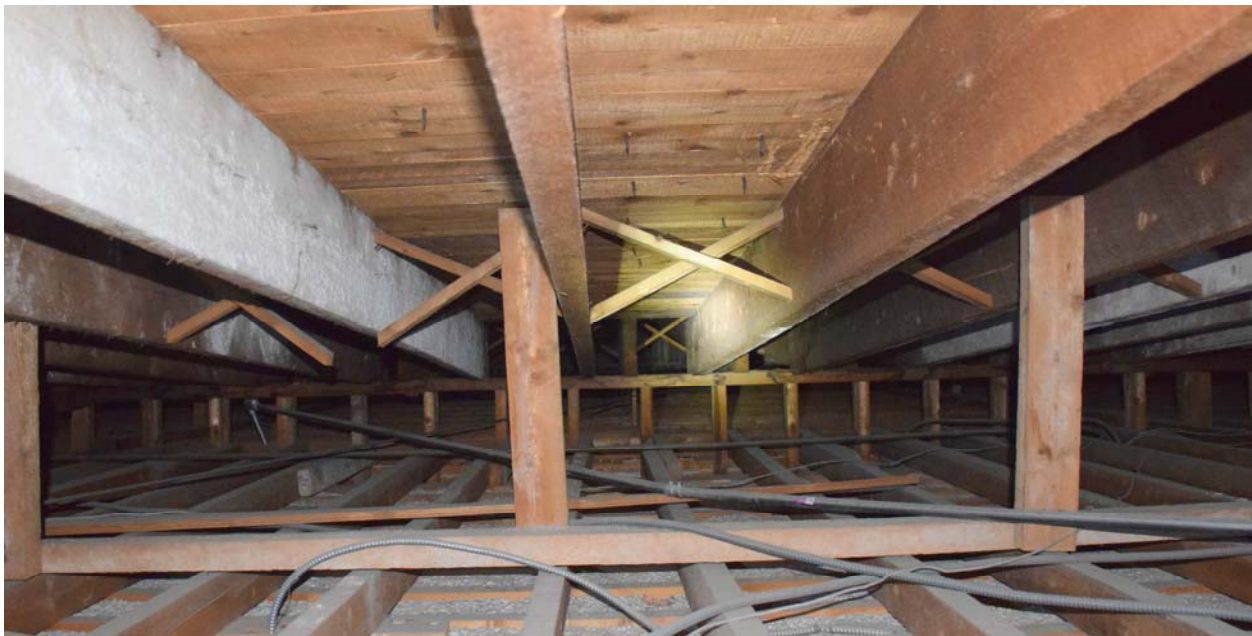
Figure 3-Roof Framing at Interior Bearing Wall

Snow loads for the original design are not noted on the original construction drawings, but rough calculations indicate that the design snow load was no more than 30 pounds per square foot (psf), which is less than the current Building Code load of approximately 40 psf for school buildings. If the renovation option is chosen, and the roof structure is altered, the existing members in the areas of the alteration will need to be reviewed with modified current snow loads to verify their adequacy. Typically, renovations to roof structures similar to this roof will require supplemental framing at any new modifications or fire protection systems. New roof mounted mechanical units should not be considered for this building, unless strengthening of the roof framing is proposed. Our view of the roof framing was limited to the area near the roof hatch during the site visit, and we did not notice distressed framing, but did notice some disconnected bridging (See Figure 3). Due to the age of the wood framing, and the light design snow load, we would anticipate that some roof framing may need to be repaired or strengthened during a full renovation and a more thorough review of the framing should be completed during the design phase.
