# 44 Wanoosnoc Road Property Assessment

May 17, 2022

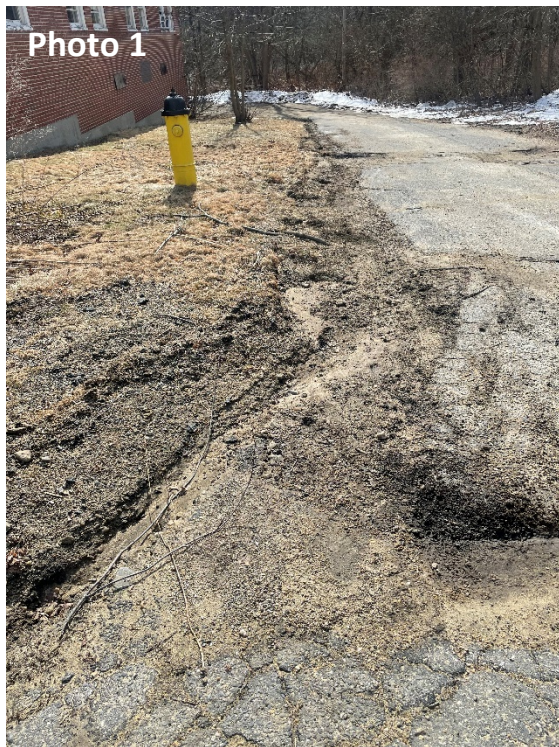
Pavement on the site appears to be in fair to poor condition. There are signs of significant wear including cracking and erosion in areas of higher use. There also appears to be scouring on site near the edges of the pavement where stormwater runoff carved out small channels over time (Photo 1). Drainage infrastructure on the site is minimal. Visual inspection did not show any outfalls discharging to the stream from the property. Observations suggest stormwater runoff collects at the southern edge of the property and drains into a stream via a channelized footpath (Photo 2).

*Photo 1 shows the driveway to the rear of the site with broken pavement and erosion from stormwater runoff. Photo 2 shows the back of the school building where channelized stormwater drains into the stream.*

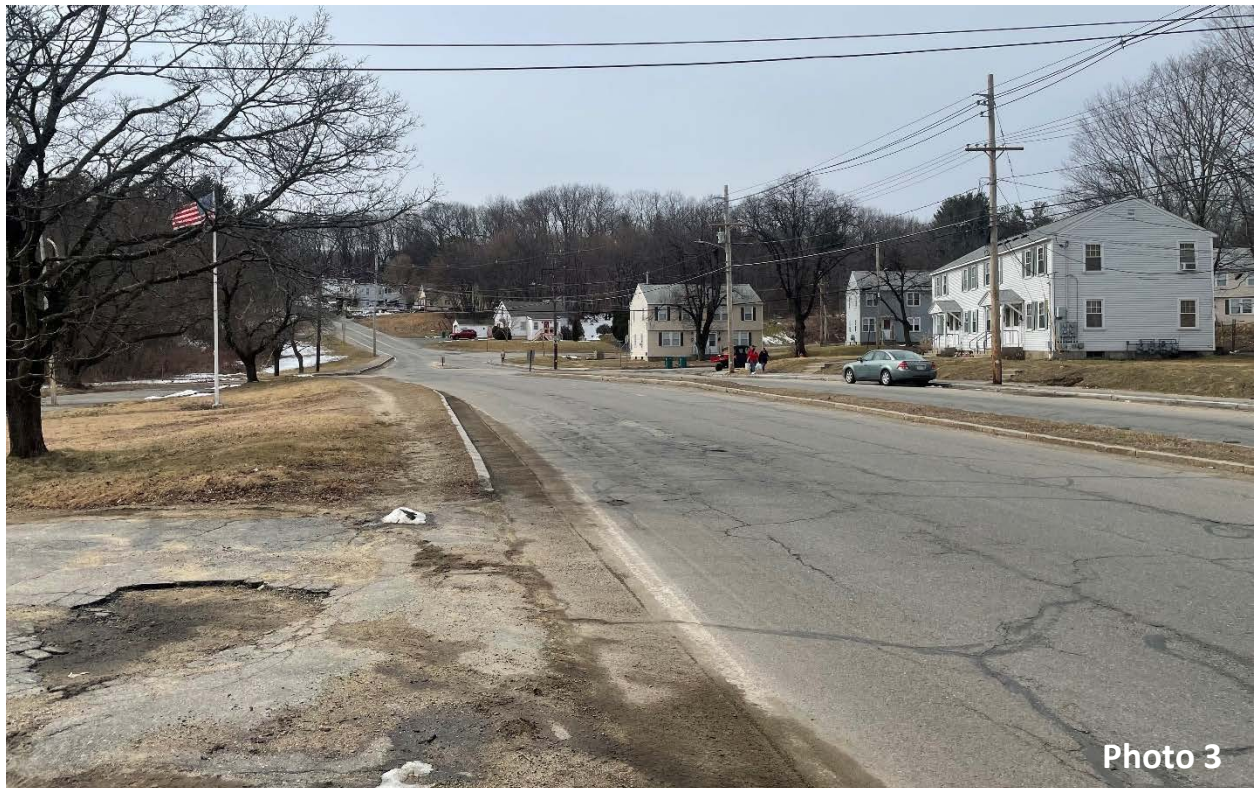
Photo 3

*This photo is taken looking west along Wanoosnoc Road across the front of the Property (on the left). The foreground shows damaged pavement across the driveway and the lack of any formal sidewalk along the street. Pedestrians have worn a path along the grassed area adjacent to the expansive road section.*

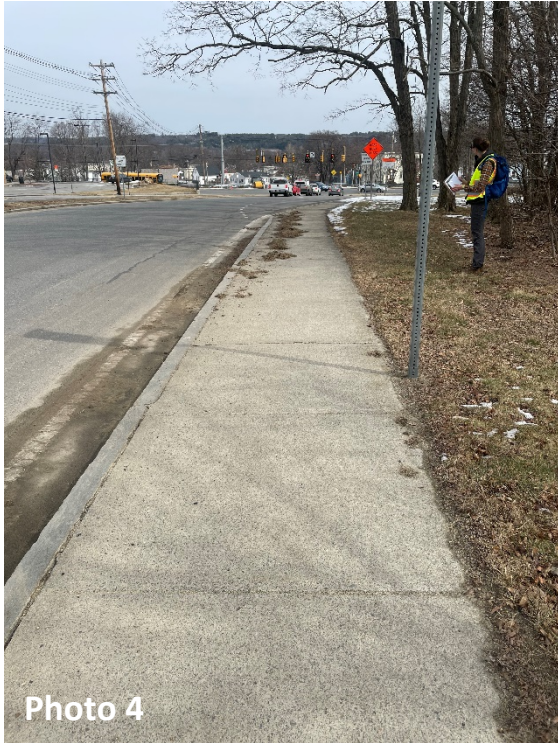
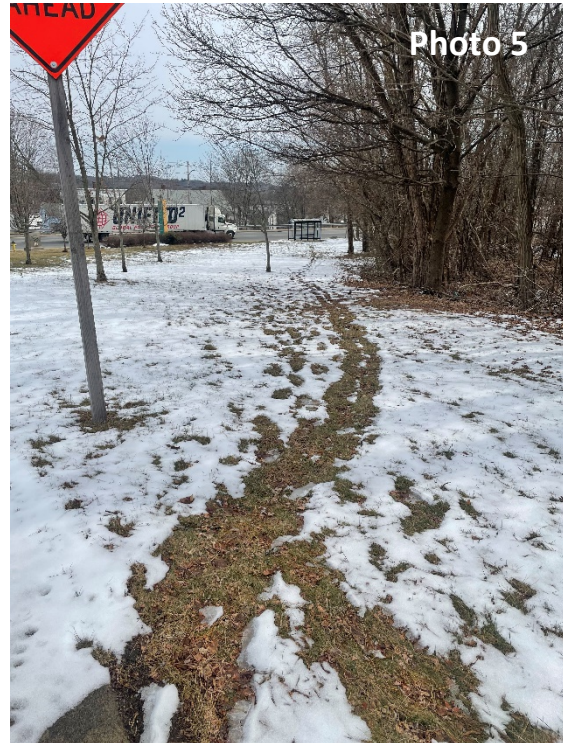
Road to the Montachusett Regional Transit Authority (MRTA) bus stop on Water Street. Many pedestrians apparently prefer to walk over the grass in a shorter line to the bus stop, rather than a slightly longer walk along the sidewalk (Photos 4 & 5).

*This photo is taken looking east along Wanoosnoc Road as it approaches Water Street. The sidewalk meets minimum dimensional requirements and is in good condition. As pedestrians get closer to the intersection, they turn off the sidewalk and walk along the grassy open space to the bus stop.*

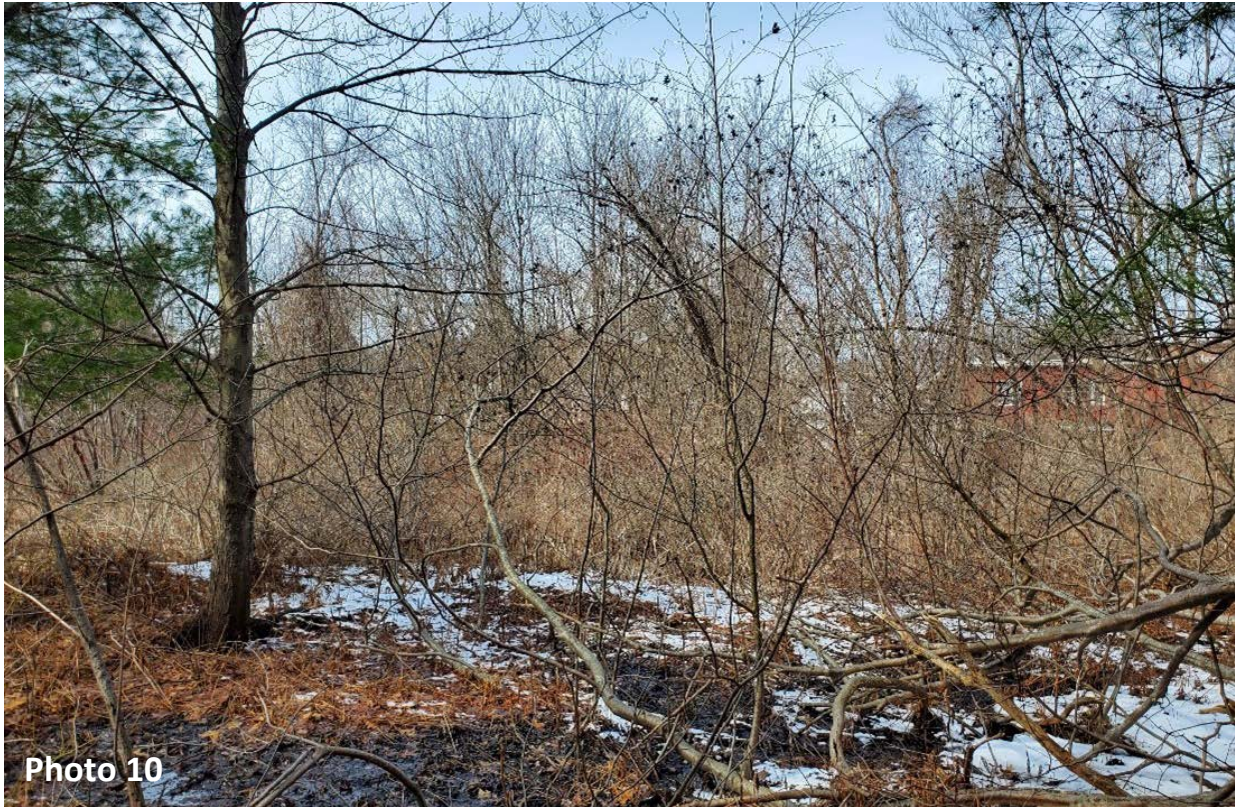
**Photo 10**

*Photo 10 above shows scrub forest surrounding the wetland area. Photo 11 below shows a portion of the braided network of intermittent streams that eventually converge into a single channel.*

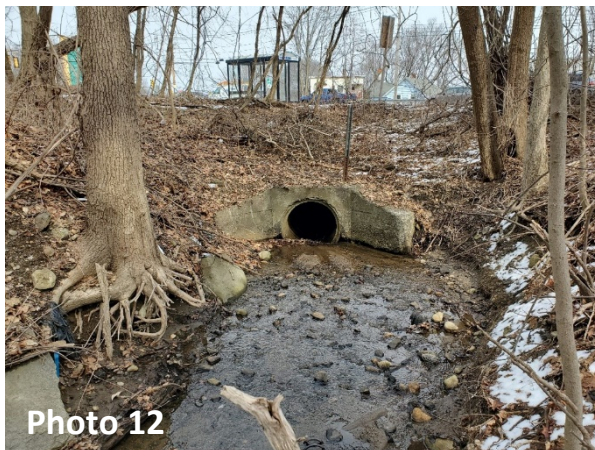
*Photo 12 shows the stream leaving the site. The Water Street bus stop is visible in the background. Photo 13 shows water entering the site from Wanoosnoc Road. The deep pool in front of the culvert suggests water flow can be high volume.*

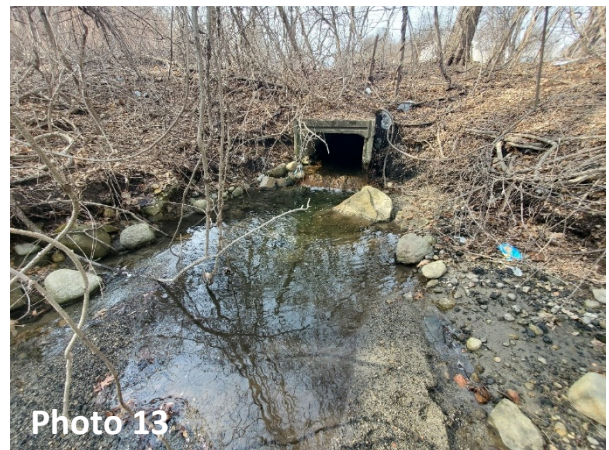
As noted above, there are multiple intermittent streams that flow along the north, central, and southern sections of the wetland area, which converge just west of the existing pedestrian stream crossing. After convergence, the stream continues to flow northeast through the property, eventually exiting the northeast corner of the site through a culvert beneath Water Street (Photo 12). The main source of stormwater inputs appears to be flowing from the larger culvert at the western corner of the property, with lesser inputs from smaller culverts at the base of the slope near the southwestern property line. The larger culvert feeds the stream section along the northern perimeter of the wetland, which shows more significant scouring where the culvert daylighting onto the site near Wanoosnoc Road, as well as deeper bank cutting prior to the location of convergence with the other stream sections (Photo 13).

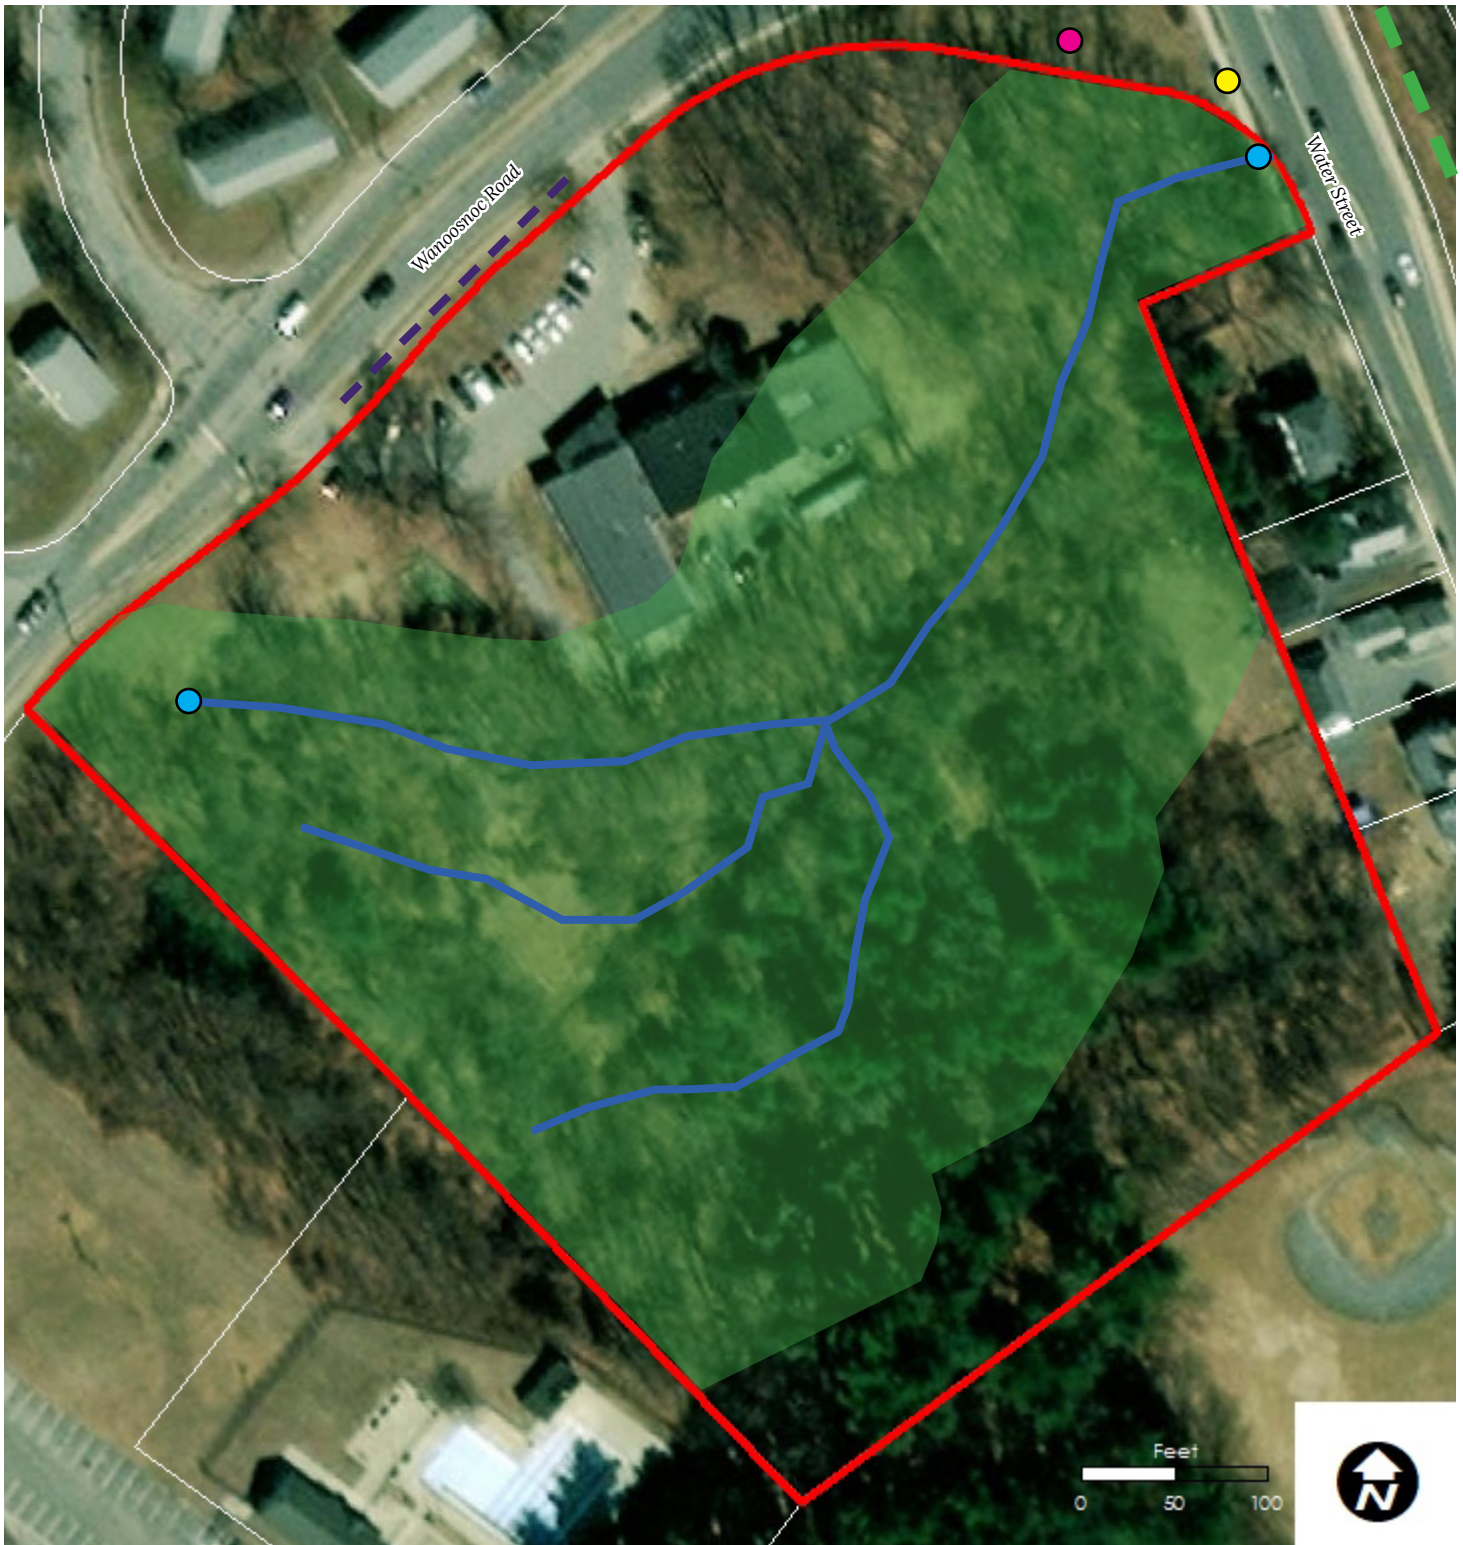
Figure 3.0  
 Approximate Wetland Jurisdiction

Any proposed work/development within the BVW areas (e.g., pedestrian bridge crossing the stream) and/or their associated buffer zones will require a Notice of Intent (NOI) application to be filed with the Fitchburg Conservation Commission and will need to be designed to meet the applicable BVW performance standards detailed in the Massachusetts Wetlands Protection Act Regulations (310 CMR 10.00) as well as the resource area protection requirements noted in the City of Fitchburg Wetlands Protection Ordinance Rule and Regulations (see 'Regulatory Considerations' section for more detail). Figure 3 shows the approximate extent of jurisdiction related to wetland resources.

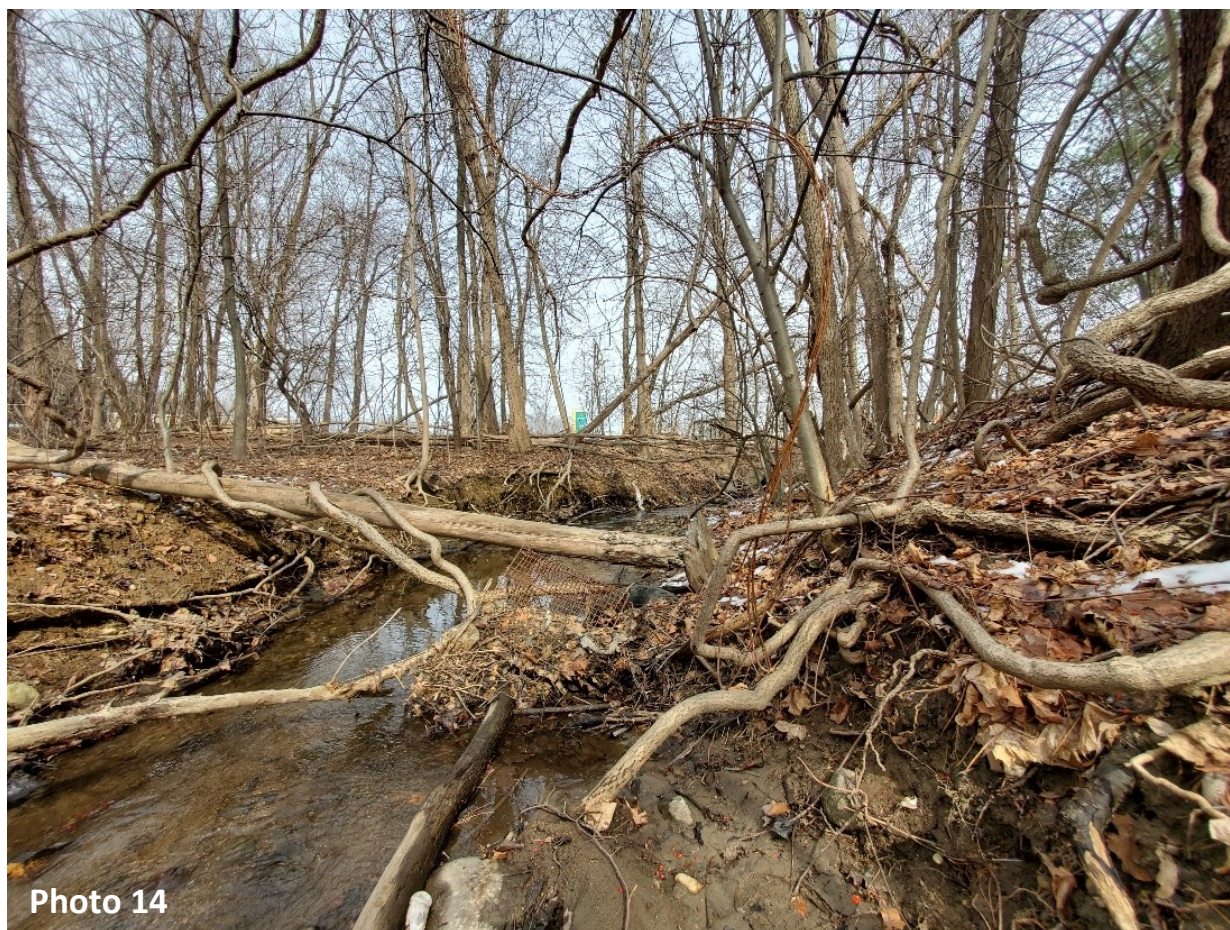
The other stream sections running through the central and southern areas of the wetland do not appear to be receiving flows that are large and/or fast enough to cause any significant erosion along their stretches. After convergence of the intermittent streams, the single stream channel flows through a section behind the school building that possesses a broad, relatively flat floodplain, which (as discussed previously) HW believes to be potential BVW on either side of the stream. The stream banks in this section appear to be lower and more stable, allowing overflow from the stream into the potential BVW areas during more significant storm events. As the stream continues to flow to the northeast, the banks become steeper and more unstable and show similar erosion patterns as those demonstrated along the section flowing north of the larger wetland at the west side of the property (Photo 14).

*Photo 14 shows the stream channel as it approaches the culvert under Water Street (Photo 12). This is an areas where the banks appear to be less stable and susceptible to erosion.*

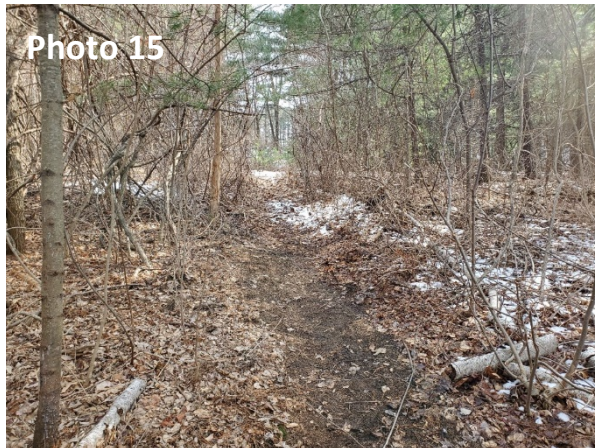
*Photo 15 shows the well-worn footpath leading south from the school to the baseball field.*

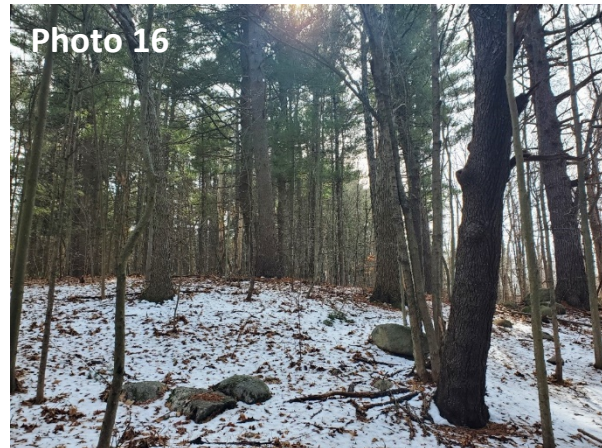
*Photo 16 shows the white pine forest that contains informal trails and many specimen trees.*

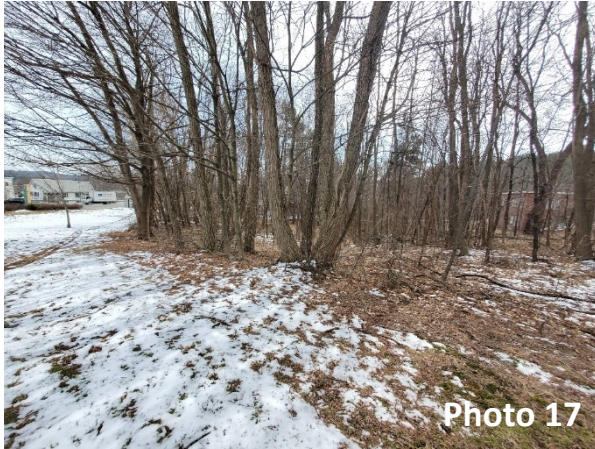
Northeast of the school building HW observed an upland area that is dominated by large black locust (*Robinia pseudoacacia*) with a few smaller cherry birch (*Betula lenta*) and Norway maples (*Acer plantanoides*) also present in the understory (Photo 17). As this area slopes down toward the stream to the south, the vegetation transitions to a more mixed presence of trees, shrubs, and vines that additionally includes crabapple, shrub honeysuckle, bittersweet vine, and staghorn sumac.

*Photo 17 shows the mix of Norway maple, cherry birch and other trees along the eastern edge of the Property. Photo 18 shows a tangled collection of invasive species.*

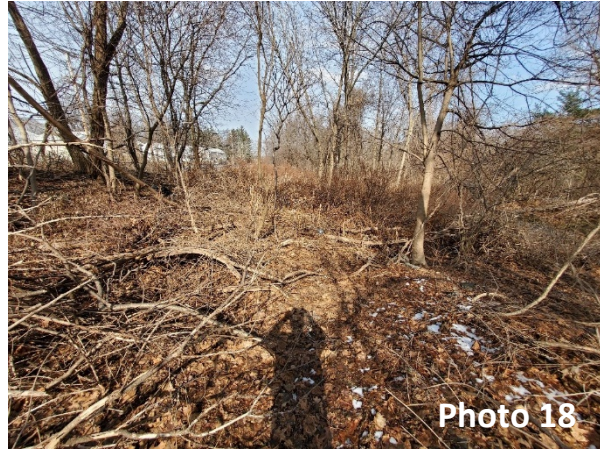
maple (*Acer platanoides*), crabapple (*Malus sp.*), shrub honeysuckle, bittersweet vine, and Japanese knotweed (*Fallopia japonica*) (Photo 18).
