Beal Early Childhood Center

Existing Conditions Report

DECEMBER 18, 2017

3.1.4 EVALUATION OF EXISTING CONDITIONS

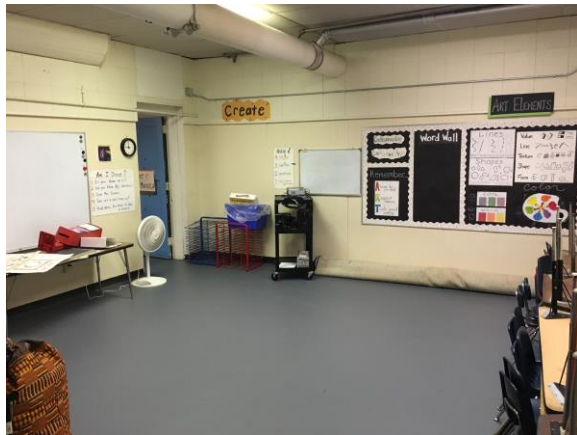
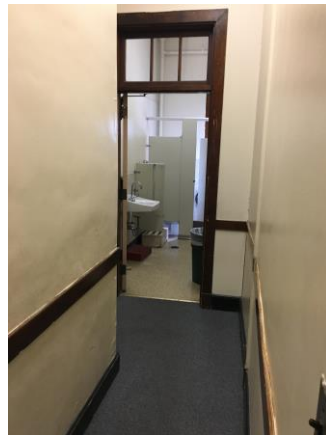
Partitions: Original masonry bearing corridor partitions largely remain with lath and plaster painted finish on the upper levels and painted masonry walls on the ground level. Newer partitions appear to be wood frame/gypsum board construction with painted finish. Many of the wall surfaces are not currently visible due to the classroom furniture and millwork obscuring the view of them. Reportedly, plaster has delaminated in some places and repair is required. Most of the newer partitions are in fair condition due to economical construction techniques and finishes used.

Exterior partitions are not insulated. For any major renovation, a carefully engineering interior insulation system would be recommended for energy efficiency. It would be important to design a system that would continue to allow the exterior masonry to breathe as originally designed. New finish systems, tie-in to any proposed replacement window system, and other details would be recommended as part of the exterior wall system improvements.

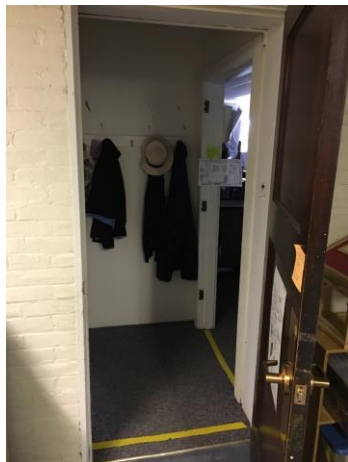
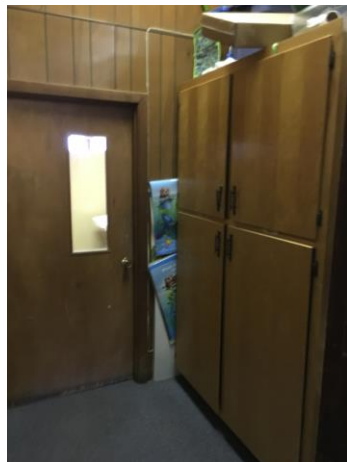
Doors: are a mix of original and replacement wood doors, some of the original doors with transoms above. Much of the operating hardware has been changed to lever style accessible hardware, but there are some remaining non-accessible compliant door handles in place. Doors range from fair to good condition and would need to be evaluated on an individual basis for a major renovation project. Due to the original exhaust chase design of the school, a large percentage of the corridor doors do not meet accessibility clearance requirements due to the depth of the wall cavities.

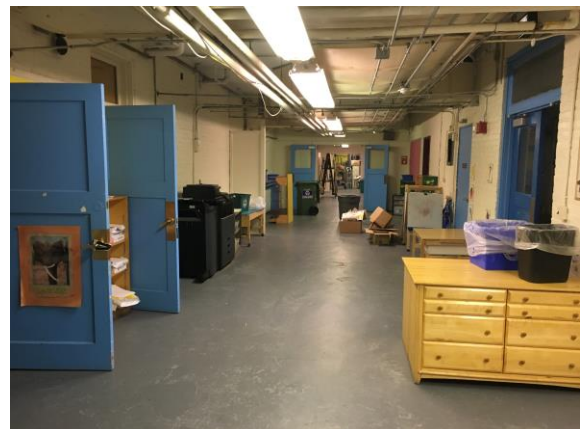
Ceilings: The upper floor classrooms primarily feature 2' x 4' suspended acoustic ceiling tile (ACT) systems that appear to have been installed in the 1980's and are in fair condition with sagging and discoloration evident. Especially since sprinkler protection installation and upgraded lighting would typically be featured for any major renovation project, it is expected that the ACT ceilings would be replaced. In corridors, the original painted plaster ceiling appears to be in place in the majority of the area. At a minimum, some repair work to ensure finish soundness would be recommended due to water leaks over the years. The basement ceiling is typically exposed structure painted.

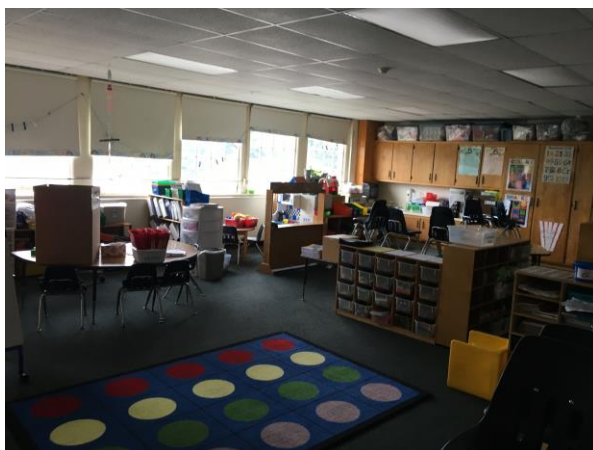
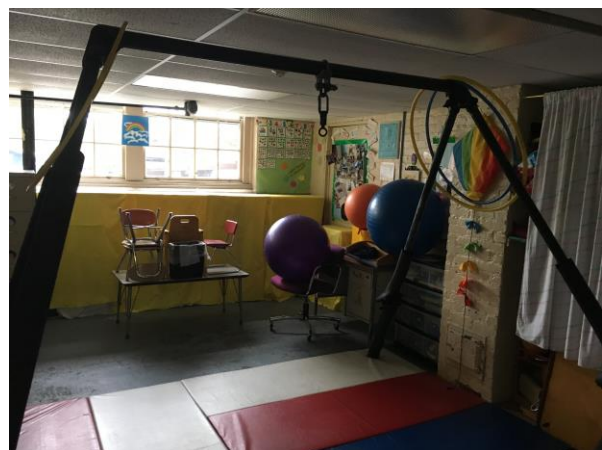
Classrooms: upper floor classrooms feature painted walls with a combination of plaster and gypsum board finish. Some have original high school millwork while most have replacement fixed and modular wood millwork in fair condition. The replacement millwork does not feature accessible sink units. Classroom finishes include, ACT ceilings, carpet and resilient flooring. While the high window sills provide more wall space for materials storage, they are not well suited for young children to have views of the exterior. Lower level classrooms are similarly appointed but have painted brick walls.

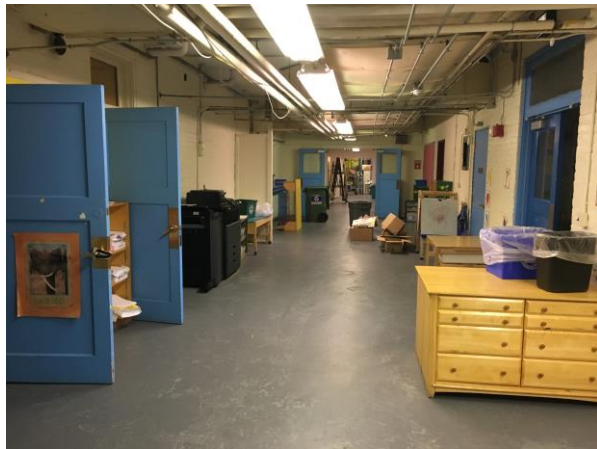
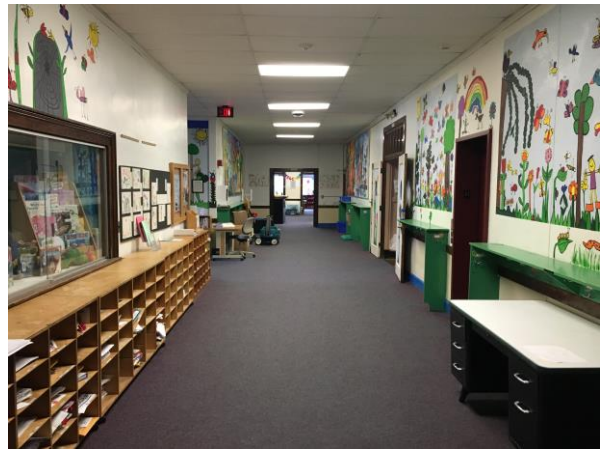
Corridors: designed originally with a wide configuration, the corridors have high plaster ceilings and an airy appearance. Currently, the extra width is reduced by the use of the corridors for cubby storage, equipment, and sinks.

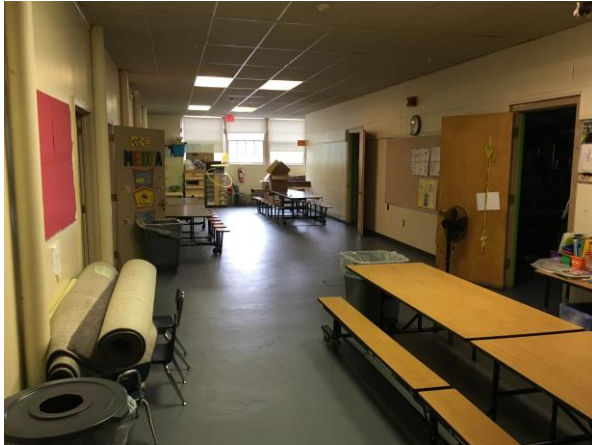
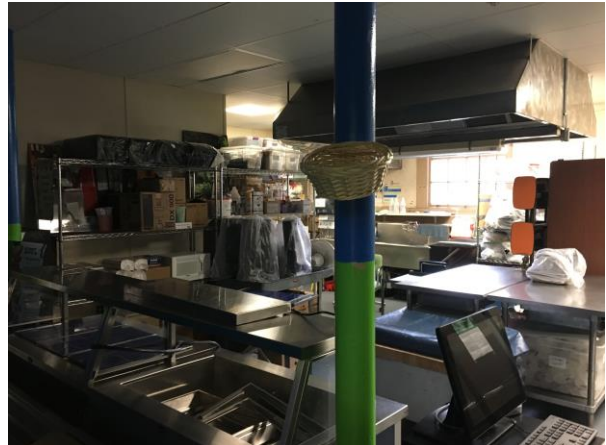
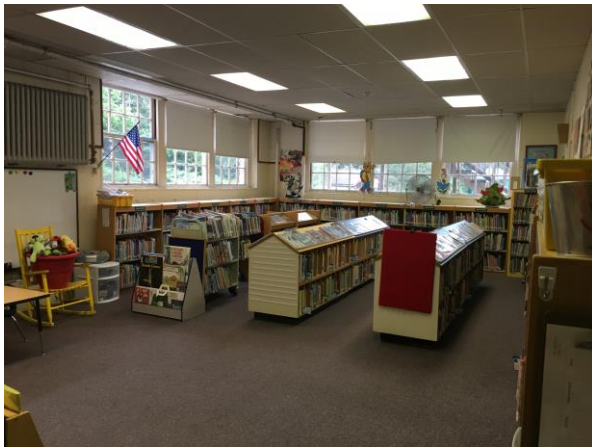
Cafeteria/Kitchen: the original manual training space was subdivided into a Cafeteria/Kitchen, Library, Art and Music space and egress ramp. Two rows of columns supporting the gymnasium space above have been integrated into the newer partitions. The ramp has been incorporated to provide egress to the grade level of the parking area. The kitchen features commercial grade stainless steel equipment and serving areas. The cafeteria space is long and narrow and more resembles a corridor than a cafeteria in configuration.

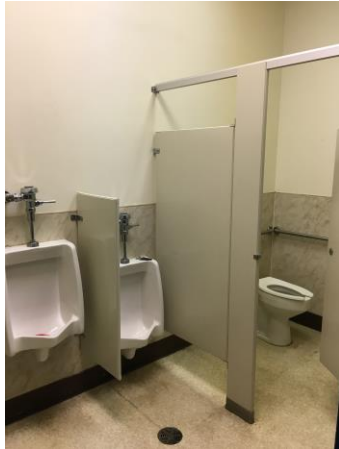
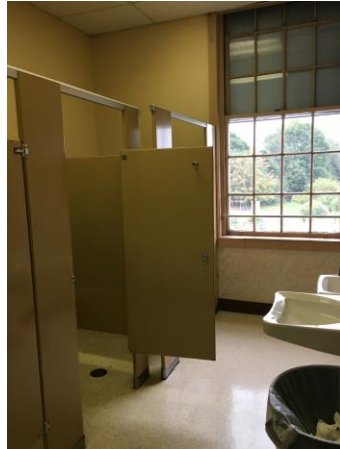
Toilet Rooms: some original marble wall finishes are in place, but most toilet partitions have been replaced with solid plastic partitions in good condition. Lowest level toilet rooms feature painted floors and walls. None of the existing kindergarten toilet rooms have adjacent toilet rooms. See the mechanical report for more information regarding the plumbing systems.

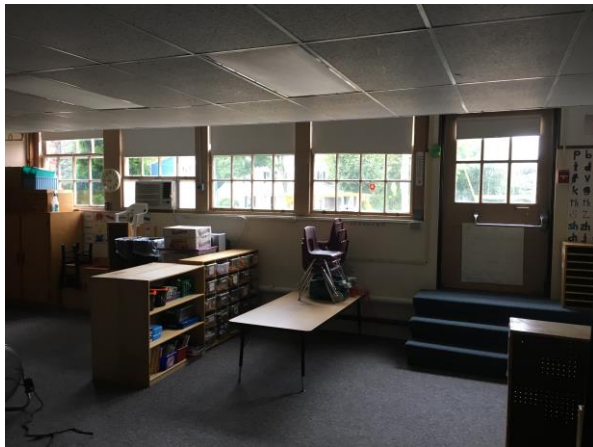
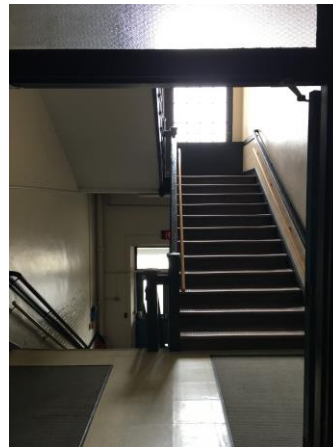
Stairs: original stairs have been covered with rubber treads and resilient landings. Walls are painted brick and plaster. One lower level classroom has steps that lead to an egress door which do not meet code as they do not have handrails or adequate landing space at the door.

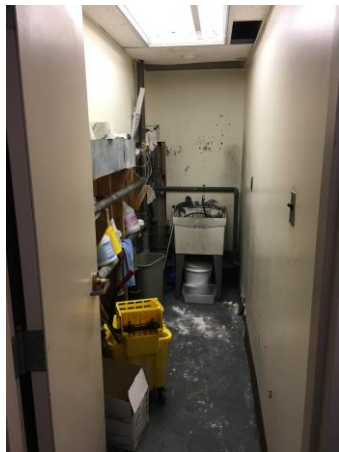
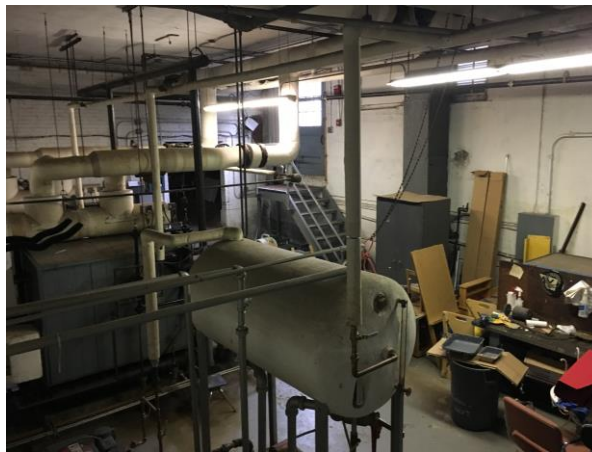
- Original shaft system exhaust was disabled at some point leaving operable windows as the only ventilation method
- The 1980's vintage boilers have been in use beyond their expected life span
- Electrical systems including technology have been installed over time including: fire alarm system, interactive whiteboard projectors, and the support the elevator system. A full renovation education project would require replacement of all systems

There is no existing sprinkler protection system in the building. Particularly with the wood frame floor and roof system, installation of fire protection would be required for any significant educational renovation project.
